Galawhistle Wind Farm
Environmental Statement
Technical Appendices

Technical Appendix 1 - Carbon Calculation

1.1 History of Peat Failure

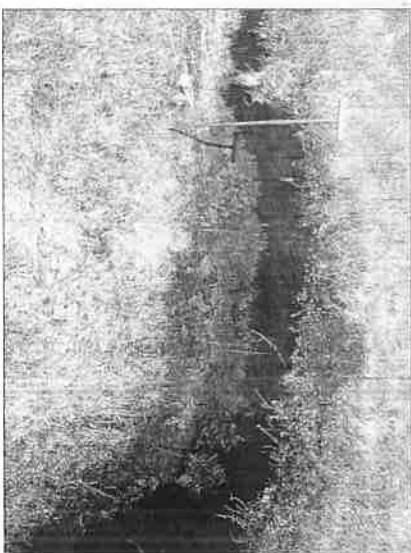
Photograph 1 Example of peat depth at Galawhistle Wind Farm

The photograph indicates the peat depth as the peat probe to the left of the photograph has a length of 1m, with the subdivisions every 0.1m. The depth of peat in this area did not exceed 1m.

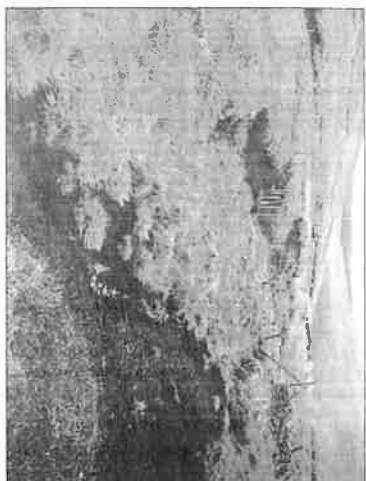
Photograph 3 Evidence of water erosion in the vicinity of Turbine 10

In the saddle between Hareshaw Hill and the minor summit to the south, in the vicinity of Turbine 10, the geomorphology of the environment is conducive to water erosion. It is possible that the geomorphology of this area has been formed as a result of wind and water erosion focussed in the vicinity of Hareshaw Hill in the minor saddle to the south. It is likely that this is a long term and ongoing process.

It is likely that the geomorphological features highlighted in Photograph 2 and Photograph 3 are inexorably linked as wind and water erosion would be more powerful within the saddles.
